## Images of England

| Location: | WHARTON HOUSE AND ATTACHED BARN,<br>WAITBY, EDEN, CUMBRIA |

WAITBY  
Wharton House &  
attached barn

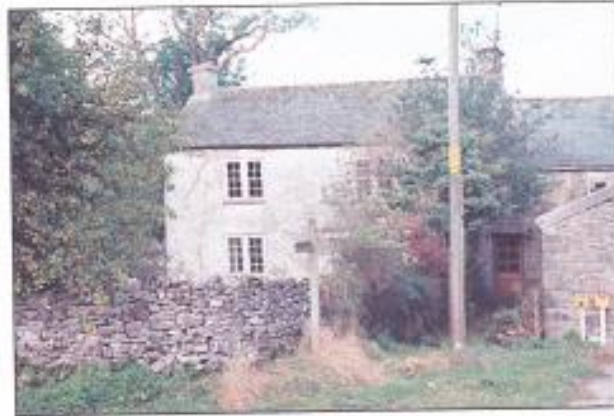
| IoE Number: | 73039 |

NY 70 NE WAITBY 6/78 Wharton House & attached barn II House with attached barn, dated 1714 with later additions. Linewashed rubble walls. C20 reproduction slate roof with corniced stone end chimneys. 2 storeys, 2 bays with lower entrance bay to right (under same roof as barn); C20 part-glazed door has initialled and dated lintel with small window to 1st floor. Main part of house has 2 paired-sash windows to each floor (sashes are later C18 replacements, but in original frames). Internally, windows have fluted pilaster mullions, panelled shutters, and window seats. Panelled heck with octagonal post. Oak doors are mostly late C18/early C19 panelled, but 2 earlier C18 panelled doors with reeded rails and stiles survive upstairs. Staircase has 2 turned balusters per tread and a ramped, squared, handrail. Late C18/early C19 8 bay
